- **Recommendations and Design for Stabilization of a Talus Slope**
- **Engineering Consultation and Oversight During Construction**

Cesare, Inc. (Cesare) provided recommendations and design for stabilization of a talus slope along the new roadway alignment as part of the Main Street Extension project in Black Hawk, Colorado. The new roadway cut through the toe of the talus slope, which brought about the need for stabilization.

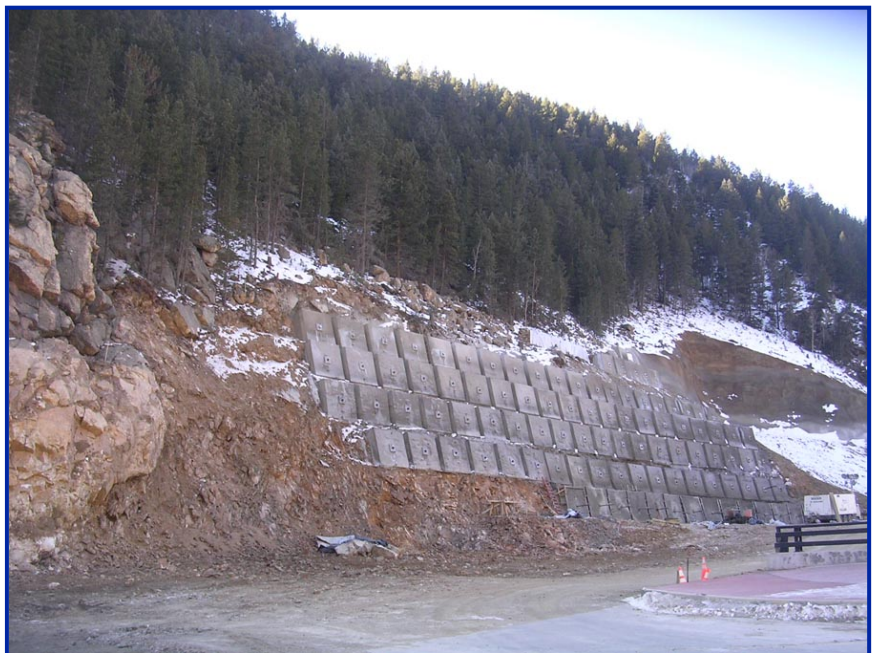
The resulting design for stabilization of the talus slope consisted of a pattern of bundled seven strand cable anchors anchored into competent bedrock below the talus. Anchors ranged from 50 to 70 feet in length. Support for the slope was provided by 8-foot square reinforced concrete anchor blocks in a uniform pattern consisting of seven horizontal rows of anchors. Because of the critical nature of the location, all anchors were tensioned to 100 percent of design load. Cesare provided engineering consultation and oversight during construction in order to determine that compliance with the design intent was met.
